MECHANICS

**PROJECT GPZ WRITE-OFF
ON THE ROAD AGAIN**

JAWS

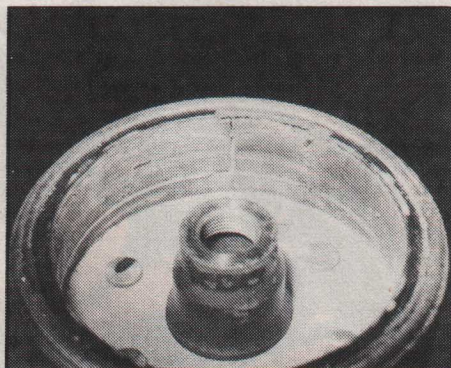
Left: The sender coils had only been lightly knocked but the damage was sufficient to stop them functioning.

In the original crash the cover over the sender coils of the transistorised ignition system had been damaged. On fairly cursory inspection, it appeared that only the cover and one of its screws had been damaged. After doing the AVO meter test laid down in the Kawasaki manual, it seemed that the coils themselves had suffered some harm. A very slight scar was evident on one of them and it seems that this had been sufficient to stop the system from working. We bought some secondhand coils from a lad we know who was breaking a GPZ, fitted them and then, at the first touch of the button, the engine fired up.

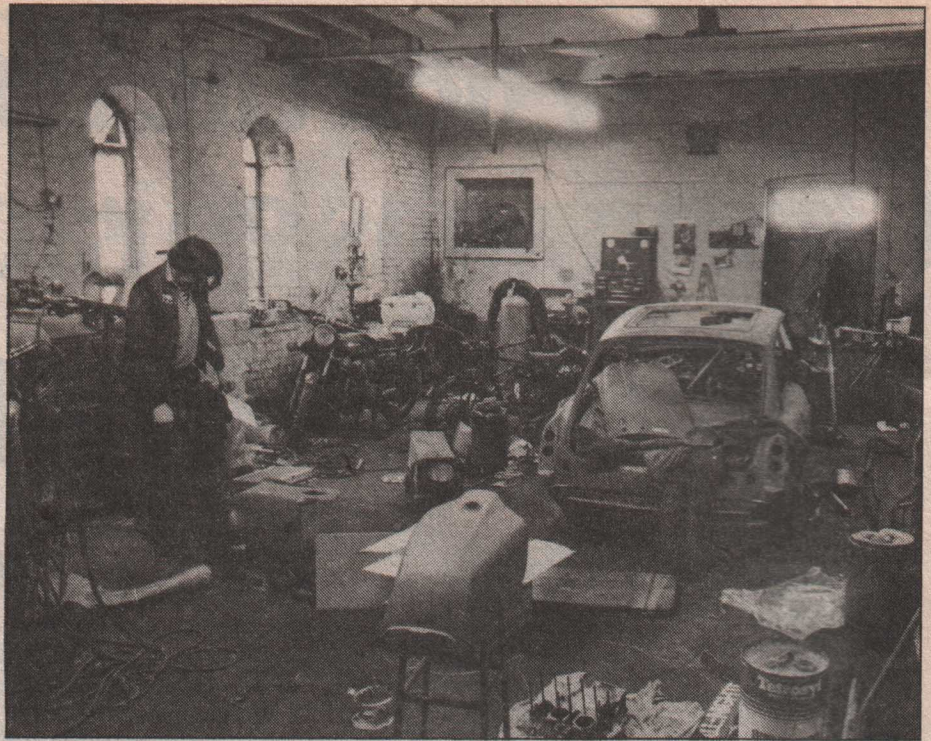
Only the tank had been sprayed with primer when we arrived at the neatly ordered paint shop in Northallerton.

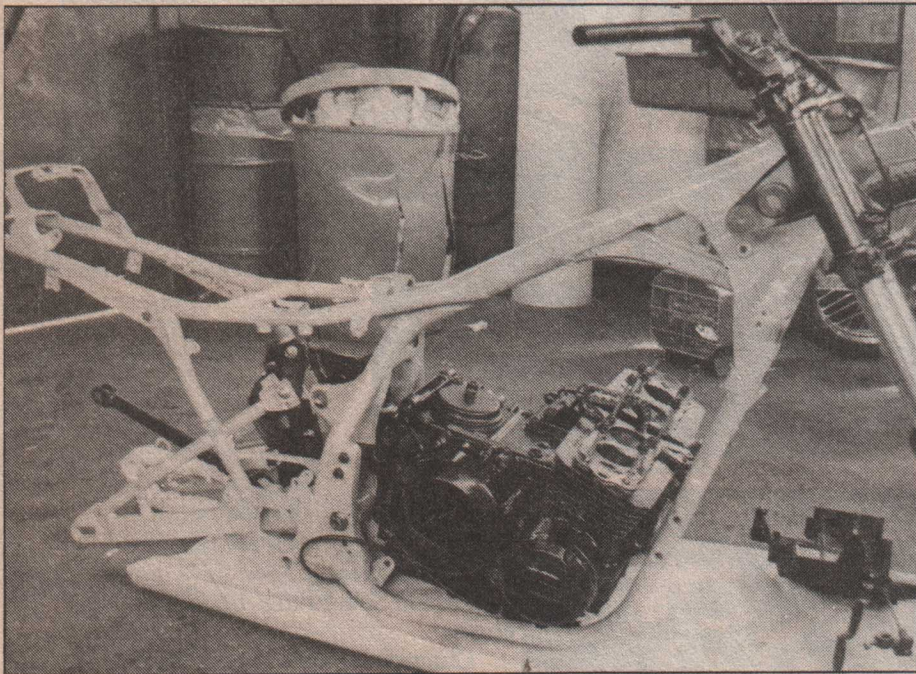
We left the head off the engine and put it in before the wheels to protect the paintwork.

That done, we laid some paper on the workshop floor to prevent scratching the paintwork on the bottom frame rails and carefully lifted in the engine, letting it sit in something near the correct position. Easier to do it that way because, had we waited until we'd got the bike sitting up on its wheels before putting the motor in, we would have been far more likely to scratch the paint in the process. Also to the same end, Colin decided to fit the cylinder head after the engine was in the frame — a smart move.

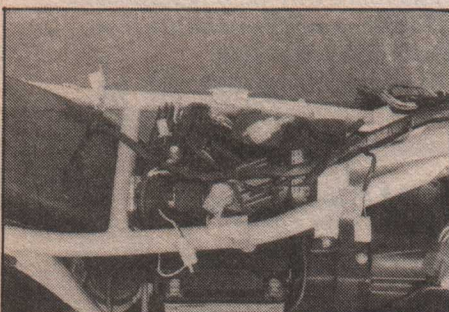
It took Lindsay several attempts to get the wires routed correctly in this area.

The CDI igniter unit, the starter solenoid, the rectifier and the fuse box of the GPz 550 are all mounted on a metal plate that sits between the seat rails just aft of the rear mounting for the petrol tank. The insulated spaghetti is pretty thick on the ground in that area and it took some time to work it all out.
