MECHANICS

**PROJECT GPZ WRITE-OFF
ON THE ROAD AGAIN**

JAWS

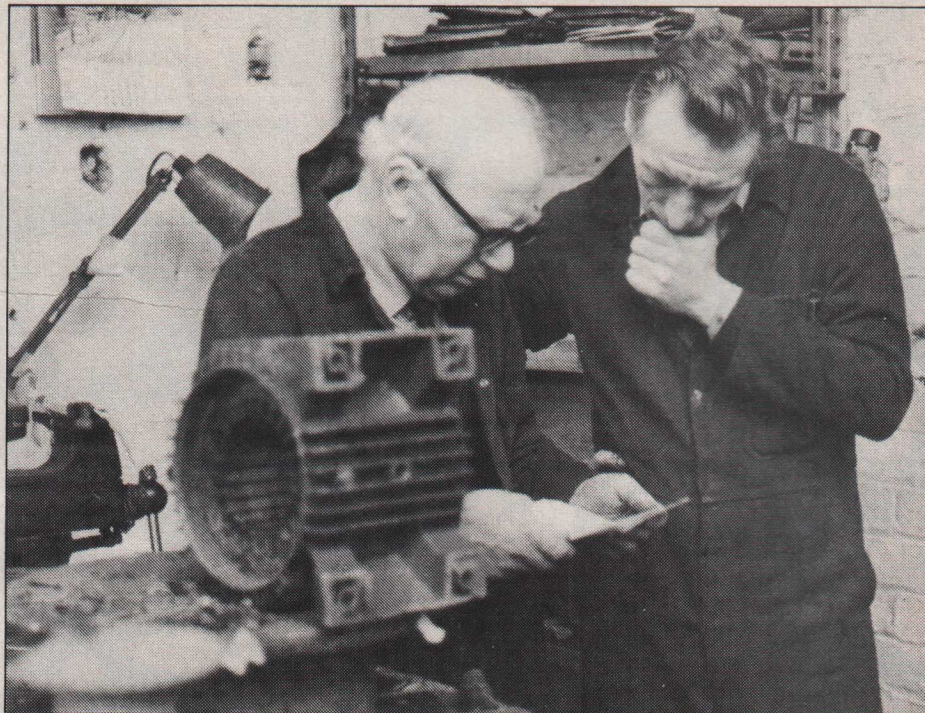
Messrs Grange and Burdett, the proprietors of GB Electrics, ponders the wonders of a Japanese alternator.

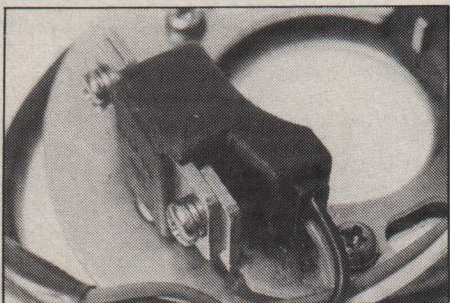
The easy way would have been to spend £74.47 including VAT on a new stator. On inspection the rotor was also in need of some attention. New rotors are pricey too. The alternator suffered damage from two separate sources. When the bike hit the road on the lefthand (alternator) side, the force which bent the end of the crank also did considerable harm to the stator core and the coils. The laminated core was badly bent and some of the coils' windings were hanging loosely. To add to the damage, the engine was still running after the crank had been bent meaning that the stator and rotor were in physical contact. This caused nasty scoring on the inside of the rotor.

Above The inside of the rotor had been badly scoured where it had rubbed against the stator during the crash.

around the laminated core. The core had been bent quite badly and had to be pressed straight under a fly press. Coils of the correct gauge copper wire were then wound around the laminated core to form the 3 phase stator. The rotor was also given the GB treatment. The scored area was cleaned up and Epoxy Resin was used to repair the damaged shielded end. They did say that they could not check that the unit would work perfectly but they felt that it would.

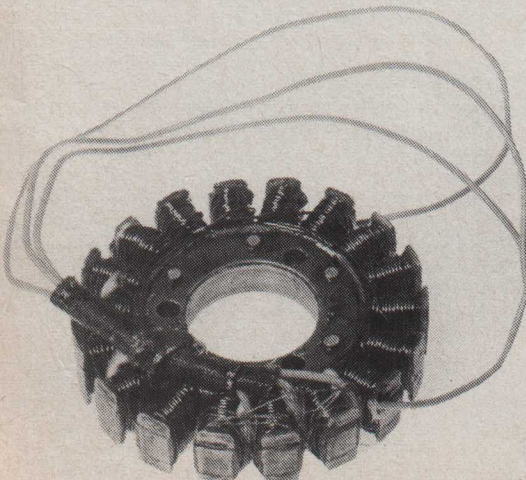
Left: The sender coils had only been lightly knocked but the damage was sufficient to stop them functioning.

In the original crash the cover over the sender coils of the transistorised ignition system had been damaged. On fairly cursory inspection, it appeared that only the cover and one of its screws had been damaged. After doing the AVO meter test laid down in the Kawasaki manual, it seemed that the coils themselves had suffered some harm. A very slight scar was evident on one of them and it seems that this had been sufficient to stop the system from working. We bought some secondhand coils from a lad we know who was breaking a GPZ, fitted them and then, at the first touch of the button, the engine fired up.

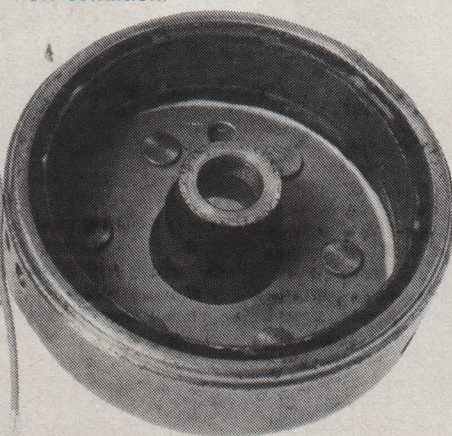
Below: For just £25 a wrecked charging system was transformed into as good as new condition.

When, some time later, the bike was fired up for the first time guess what? A steady 14 volts charge from the rectifier. Not really a surprise when you appreciate the skill of the people at GB. The cost was a mere £20.

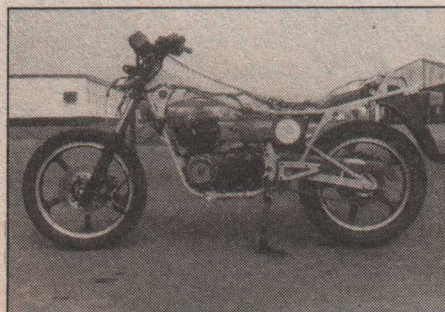
Halfway there. Lindsay and Taylor spent the Bank Holiday getting it back together.
